CASTLE

-Berlanga de Duero-

- HISTORY -

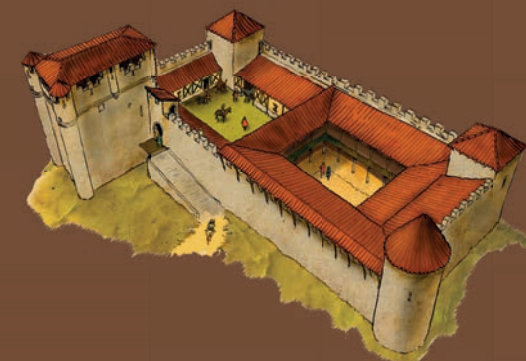
Hypothetical reconstruction of the castle at the time of Luis de Tovar

The medieval castle has a rectangular plan divided in two: a parade ground and a courtyard. It was surrounded by four turrets, each one having a different shape. The two turrets at the back, of which barely anything remains, were rectangular and within the line of the walls and therefore relatively inconspicuous. On the other hand, the front turrets are more imposing. One of them is located in the south corner whereas the other, the keep, is in the west corner projects beyond the wall.

The entrance to the castle is up a slope beside the keep. The parade ground, entered by a fortified gateway at the top of the slope, lies to the west and leads to a galleried courtyard intended as the residence of the lord of the castle. The remains of some of the gothic columns, of the paved floor and of the drain that leads to the castle's well, can still be seen in this court ground.
